INSWORKE TIDE MILL
MILLBROOK, CORNWALL

Archaeological Report
Building Record
and
Interpretation of the Mill

This Archaeological Report, Building Record & Interpretation of Insworke Tide Mill, Millbrook,
Cornwall

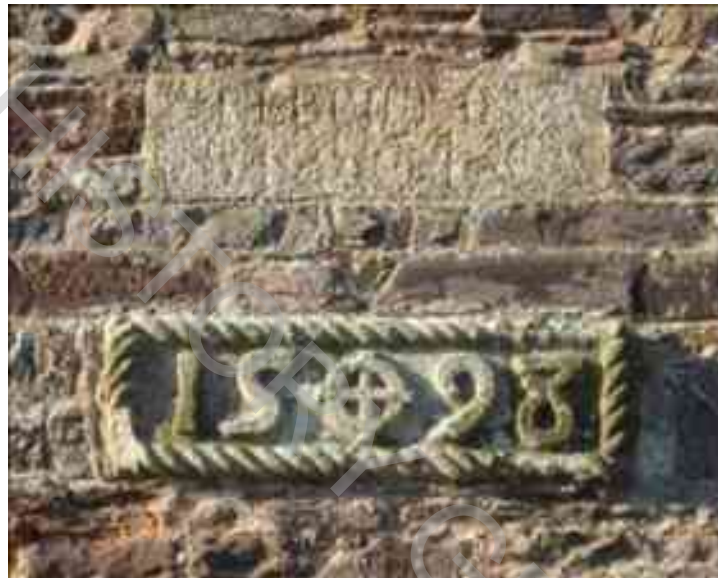
The granite stone is flush with wall and the Roman lettering is carefully chiselled complete with serifs. It is however quite shallow and has been scoured clean at each end so removing parts of the inscription. In 1937 Rex Wailes recorded the stone as:-

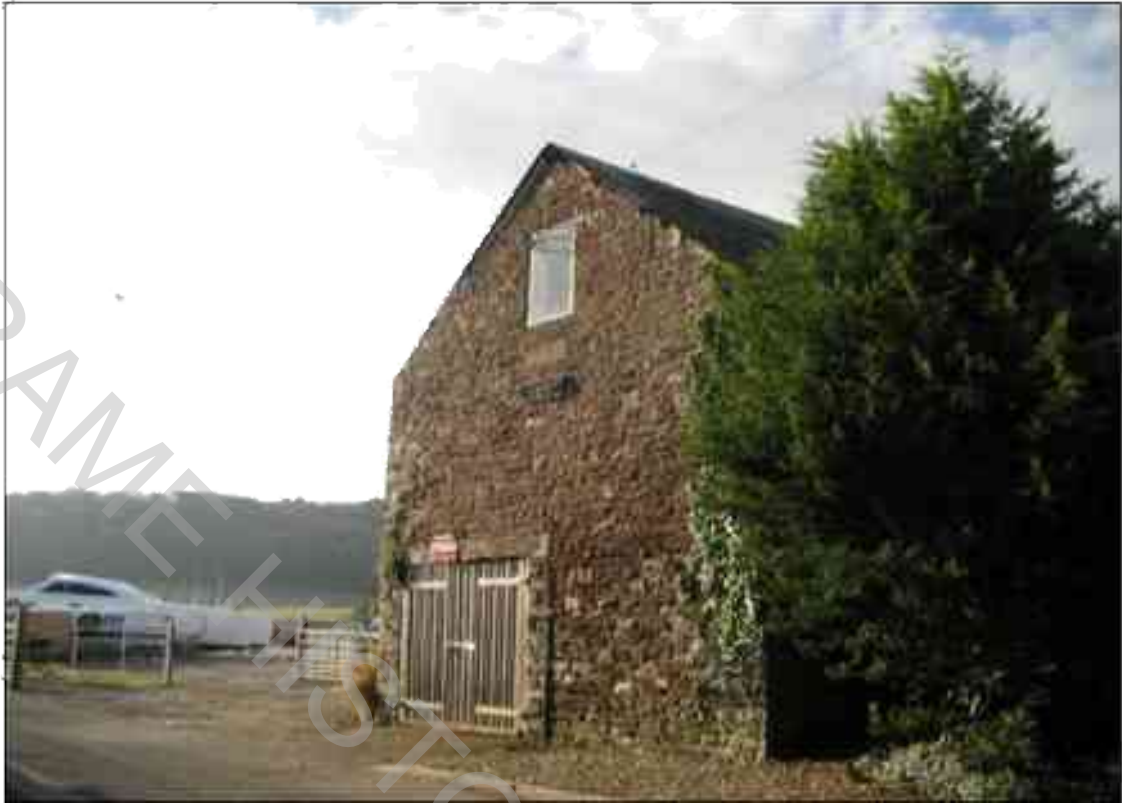
North Wall in 2008 with date stones below the window

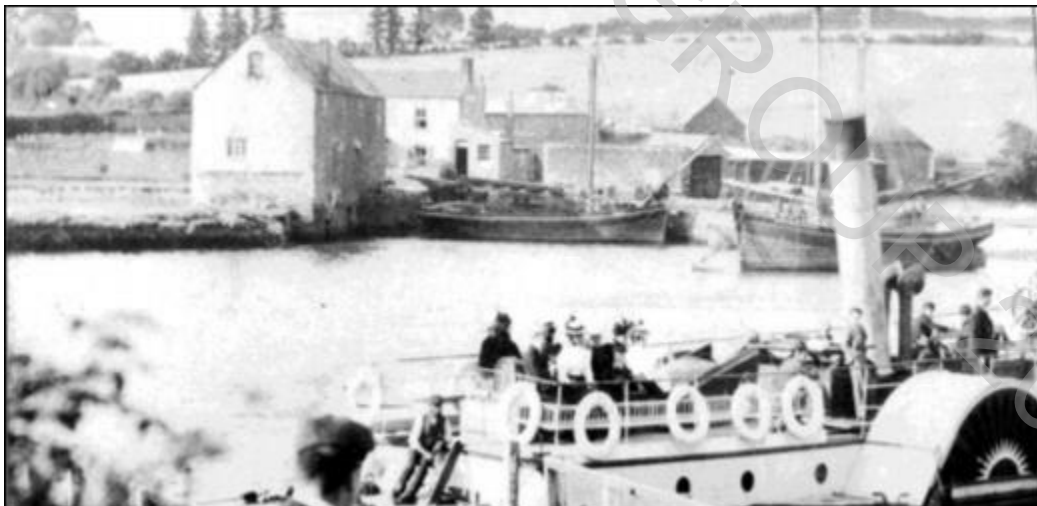
This detail from the above postcard shows the Mill with a slate roof and a chimney stack, parts of the Mill Pool wall with its sluice opening next to the Mill building and the Mill House behind. Tamar barges are alongside John Parsons' quay.

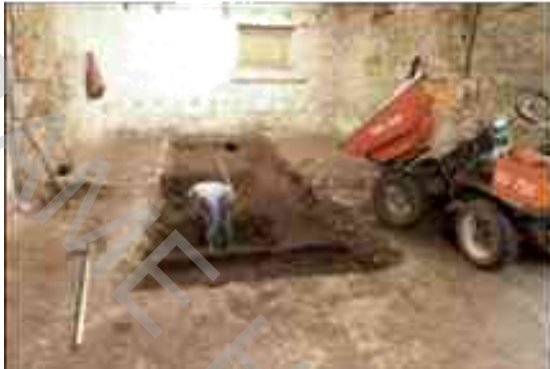
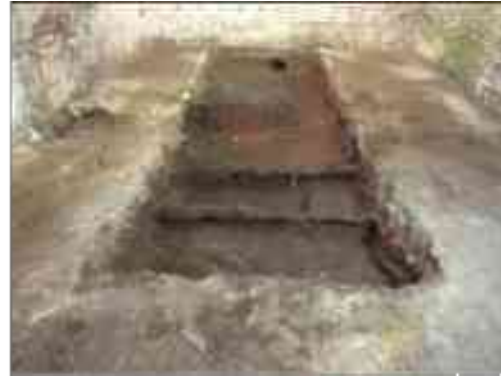
An evaluation trench was dug by hand and a light machine at the south end of area C. This showed that the worn and uneven concrete floor (C.01) lay over a loose laid brick floor (C.2) set on a layer of fine black clinker (C.03). Below this was a fill of red clinker (C0.4) with some waste bricks which was probed down to about two metres below the concrete floor. This clinker was later shown to fill the whole Basement down to the original stone floor level. The clinker came from the waste tips of the local brick works – there being two within half a mile of the mill. It was datable by the finds of early 20th century earthen wares such as teapots, marmalade jars, lemonade bottles and glass medicine bottles which had come in with the clinker waste.

Evaluation Trench looking south

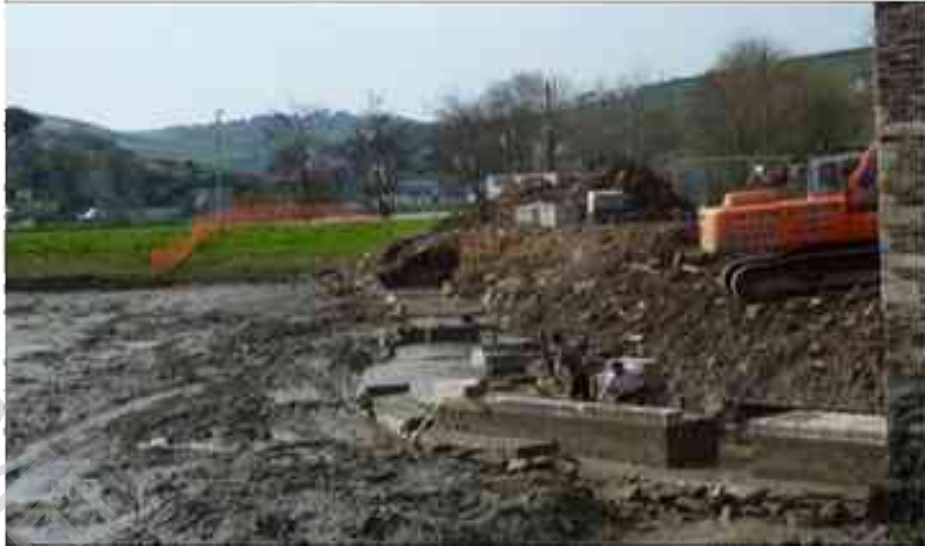
Clearance of the foreshore to the south west of the mill and foundations of the new quay wall. Behind the opening in the block-work the remnants of an earlier adaptation of the Mill Pool sluice which had a twentieth century drainage pipe across the top can just be seen. Beneath and beyond the machine is the rubbish dump fill.

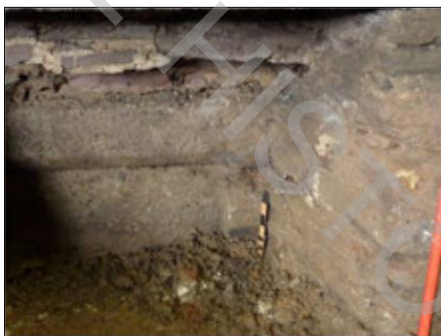
Four dressed granite items were found used as lintels and blocking stones in sluices S3 and S4 in the west wall. A piece of octagonal mullion (St 9) was included in the blocking of sluice S3. Also in this blocking was a slab (St 10) which was chamfered and stopped and may have been part of a door frame or fireplace. This seems to have been re-used as an edging slab as it has fixing holes on its outer, west face. Two different window sills each with a seating for a mullion were re-used as lintels on the inner and outer faces of sluice S4. These items indicate the high quality of the original Tudor building.

S3 west interior St 9 and St 10

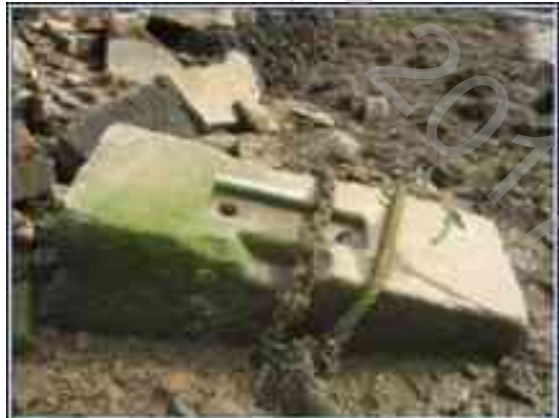
*Re-used stones in outer blocking of S3 west
sluice with 16th century sill as lintel*

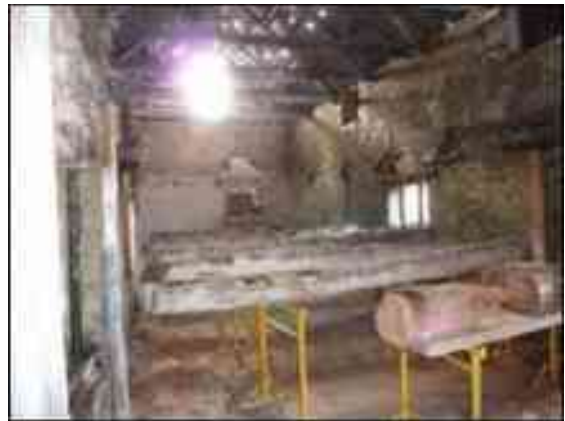
First floor beams cut down looking south with rot-ten stumps retrieved from the wall in the foreground

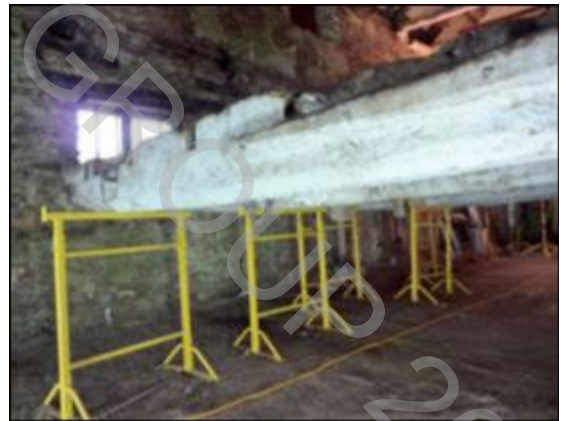
First floor beams cut down with Beam 5 in foreground. Note the iron hasps in the side and underneath which would have been used to lift the mill stones for dressing.

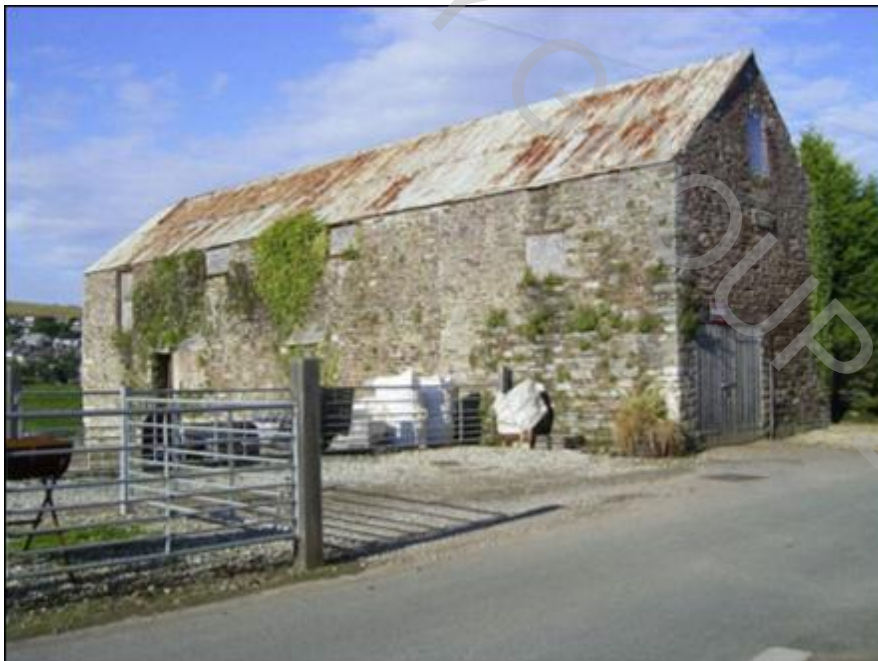
An Extension to the north end of the original mill provided covered access for carts and extended storage on the ground and upper floors. Straight joints clearly separate this new build as does the geology of the walls where quoins are predominantly slate-stones and there is a noticeable inclusion of blue elvan stone. A trap door in the first floor of the Extension and a sack ramp through a new first floor door (D4) gave access to the old building. The building is divided into two, areas A and B, by a wall on the ground floor and had a first floor and a loft. The roof timbers matched repairs to the main roof which were fixed with iron ties. This part of the building pre-dates 1911 as it appears on a photograph of that date; but the recently reviewed date stone of 1861 gives a very likely date for this Extension.

The mill from the north east showing the 19th century Extension with cart door onto the road and date stones for 1861 and 1598 in the wall above

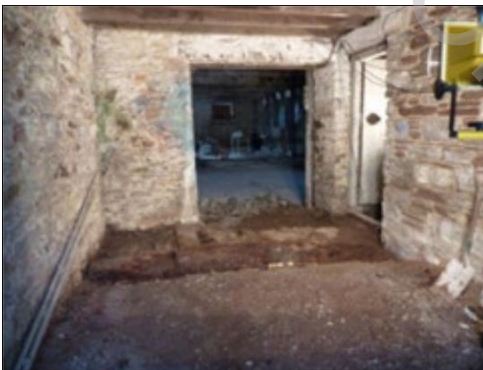
Looking south through the Extension Area A. Door D2 to the right; door D3 ahead. Excavated area on threshold of D3

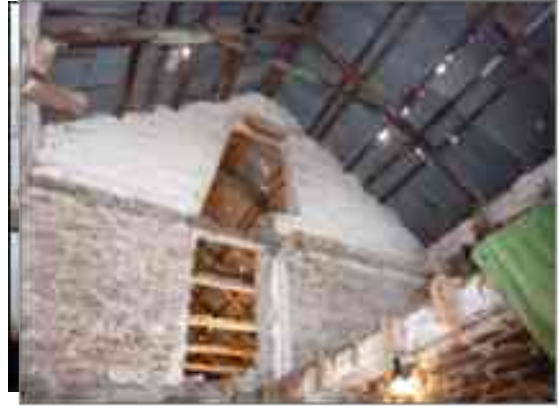
Area A Looking south up to doors D5 (above) and D4 (below). D5 was the original opening in the north wall of the main mill for hoisting sacks into the loft; D4 was broken through when the Extension was added

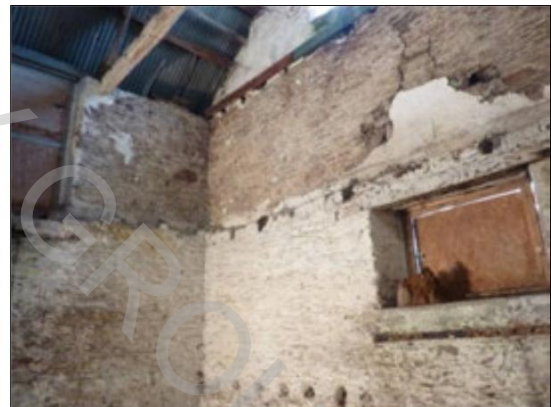
A row of small joist holes hacked into the inside of the south wall to support a subsidiary floor, the building of the fireplace and the enlargement of window W1 appear to be alterations for 20th century office space which caused the removal of the first floor beam, B8.

Early 20th century blocked Fireplace in the east wall

Joist holes in the lower part of the south wall for adaptation for office

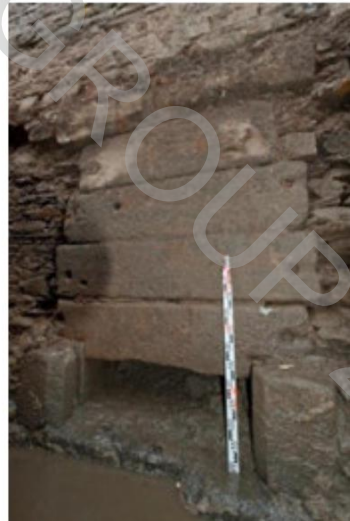
Robbing of the stone from the sluice access platform outside the south wall left the foundations of the mill in a poor state. It is likely that this happened in the 1960's while the Mill Pool was being infilled as a Caradon District Council rubbish dump.

Details of the Sluice Blocking S3 in the outside face of the West wall. The lintel is a re-used 16th century window sill with a seating for a mullion. The main blocking slabs are probably capping stones from the local quay and Mill Pool walls. The upper stones are however also recycled 16th century material, details of which could be seen on the inner faces. The carefully shaped stones to take sluice boards sit on the stone paved floor of the sluice channel. This was the only point on site where the bottom of the sluice channel was accessible and measurements from this have been projected to establish the levels in other channels.

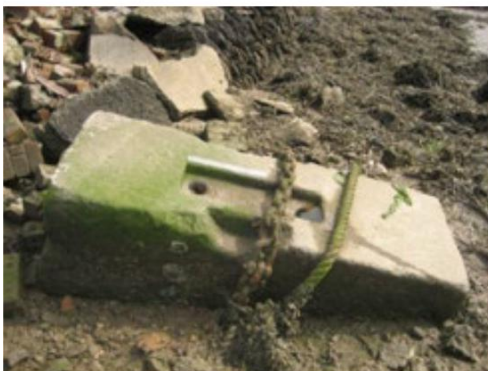
The only other feature that can be directly connected with the working parts of Insworke Mill is the substantial dressed granite block, found on the edge of the tidal creek to the south of the mill. This is identified as a bearing block which carried a horizontal bearing, most probably for a waterwheel shaft.

An interesting feature is that there are curved recesses in the tops of both side faces and it would appear that either the block was re-used or that it sat on the dividing wall between two of the waterways and carried the outer bearings of two wheelshafts, which were of different diameters.
